## DETECTION AND QUANTIFICATION OF INTERGRANULAR CORROSION AROUND WING SKIN FASTENERS USING THE DRIPLESS BUBBLER ULTRASONIC SCANNER

Daniel J. Barnard and David K. Hsu  
Center for Nondestructive Evaluation  
Iowa State University  
Ames, Iowa 50011

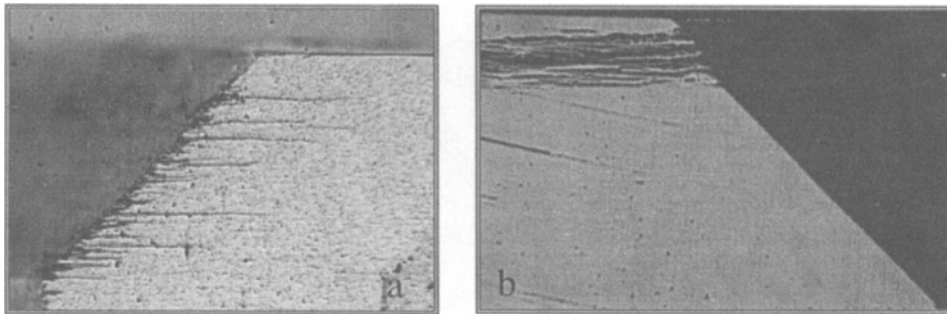
Fig. 1 a) Chemically induced corrosion in KC/C-135 wing skin material and b) naturally occurring corrosion.

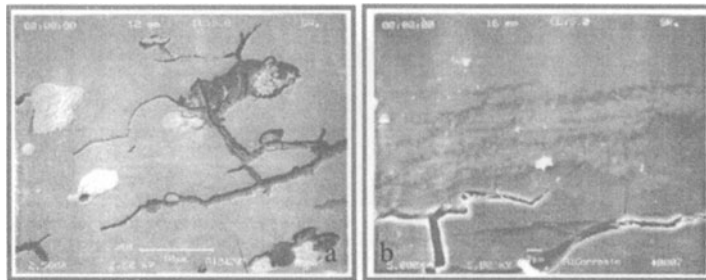
then progresses into the plane of the wing skin sheet. The morphology and orientation of the corrosion are directly related to the microstructure of the aluminum wing skin. Because the wing skin material is a rolled product, the microstructure resembles stacked sheets of grains. Scanning electron microscopy revealed that the corrosion extends out into the plane of the wing skin along grain boundaries. Figure 1a and 1b show the difference between chemically induced corrosion produced by ARINC for this study and naturally occurring corrosion. Diffusion along grain boundaries is much faster than diffusion in the bulk of the grains, so it is not surprising to see needle-like extensions of corrosion product hundreds of microns out into the plane of the wing skin, as in Fig. 1a.. Grains eventually become encircled and then slowly converted to corrosion product, as shown in Fig. 2a and 2b.

Fig. 2 a) Intergranular corrosion advancing along grain boundaries and encircling individual grains and second phase particles (bar represents 10µm) and b) diffuse growth of corrosion into the bulk of a grain (bar represents 3µm).

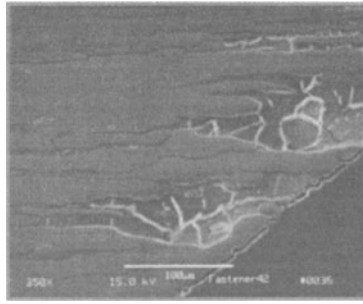
The microscopy work also revealed cracks in the corrosion product, which was very easy to locate by increasing the accelerating voltage of the SEM. The corrosion product (an insulator) could not dissipate the charge, which would tend to build up on the edges of the cracks, as shown in Fig. 3. When considering the interaction of ultrasound in the wing skin, it was thought that the impedance mismatch between the aluminum base material and the corrosion product would be the source of reflected sound energy. However, it is believed that the interaction of sound energy with the near-perfect reflector (the crack) is the primary source of reflected energy. This would explain the strong reflections noted from these thin (1-5 mm or  $\sim 1/100$  of a wavelength thick) sheets of corrosion.

Fig. 3 SEM micrograph showing charge buildup on crack edges in corrosion product (bar represents 100 $\mu$ m).

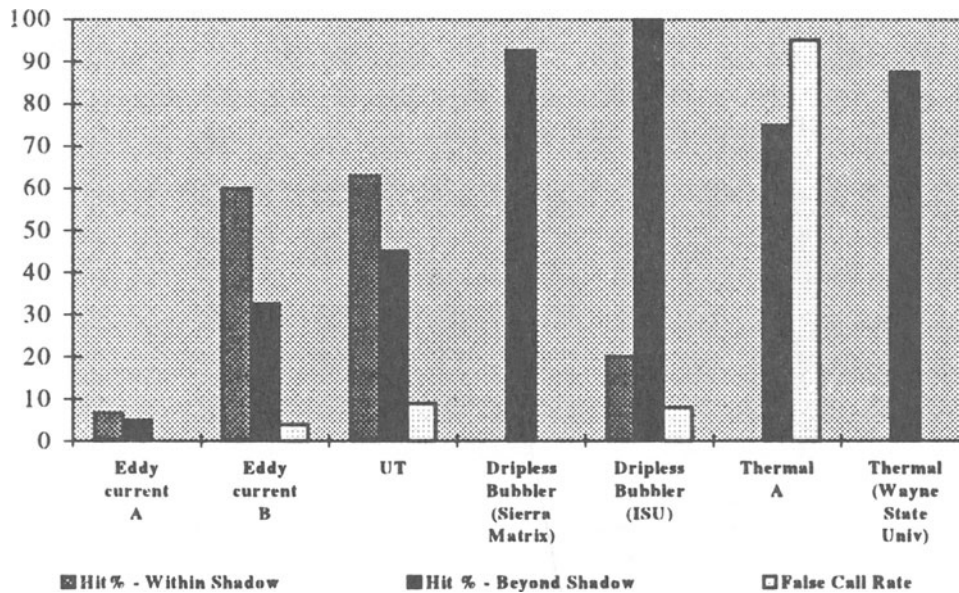
**Hit Rate and False Call Rate for  
Corrosion Detection Around Wing-skin Fasteners  
ARINC Tests, 1997**

Fig. 4 ARINC chemically induced intergranular corrosion trial results.

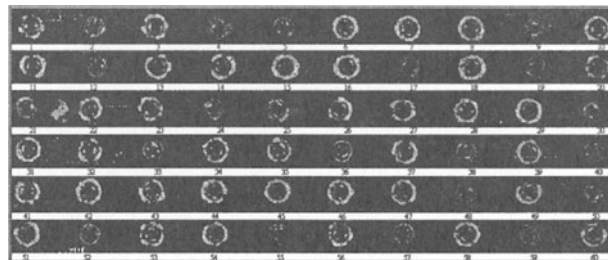
Fig. 5 Amplitude C-scan of KC/C-135 wing skin material with chemically induced corrosion in 40 of 60 fasteners.

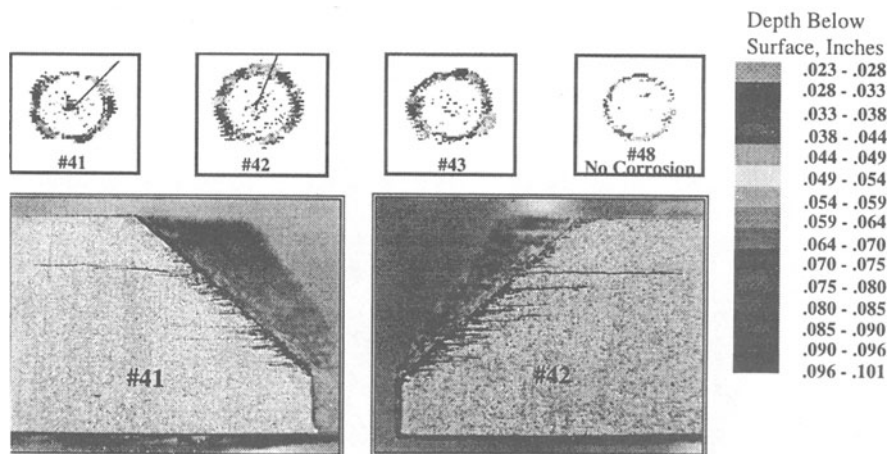
The ARINC trials consisted of examining samples of KC/C-135 and B-52 wing skin material that was drilled and countersunk for new fasteners. Prior to installing the new fasteners, the sample skins were treated to a proprietary solution that induces intergranular corrosion at an accelerated rate. After exposure, new fasteners were installed and the panels made available to the trial participants. The results from seven participants is shown in Fig. 4. Altogether, three KC/C-135 sample panels contained 60 fastener countersinks, 40 of which were treated, and 15 treated out of 20 fasteners countersinks in the B-52 sample panel. Note from Fig. 6 that the Dripless Bubbler from Iowa State detected all 40 corroded fasteners in the KC/C-135 panels with a single false call, and the Dripless Bubbler from Sierra Matrix, Inc., [7] detected 37 of 40 with no false calls. Figures. 5 and 6, examples of amplitude and time-of-flight C-scans produced from the full waveform data collected, demonstrates why the identification of corroded fasteners was not difficult. With corrosion extending out past the edge of the countersink, a wide "halo" was visible and quite unmistakable when compared to the uncorroded fasteners. Figure 6 also shows the excellent depth resolution demonstrated by this technique.

Fig. 6 Time-of-flight C-scans of corroded and uncorroded fasteners and optical micrographs indicating depth of corrosion below skin surface.

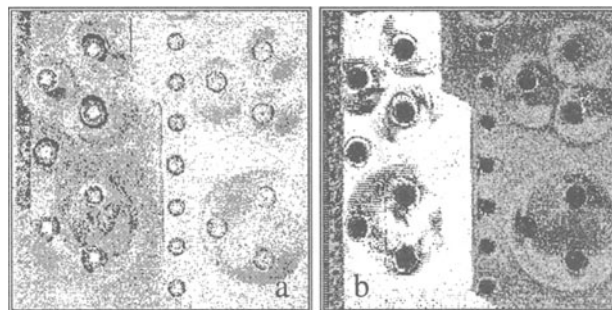
Fig. 7 a) Amplitude C-scan processed from a gate of the countersink region and b) Amplitude C-scan processed from a gate of the back wall amplitude.

schemes. Figure 7a is an amplitude C-scan of the test panel produced by a flaw gate located to detect defects in the countersink region only. Figure 7b is also an amplitude C-scan, but was produced by a flaw gate located to detect only the changes in back wall amplitude reflections. Both gates are capable of identifying intergranular corrosion and have been demonstrated not to be adversely effected by paint or blend outs from prior maintenance. The rationale for using the two gates noted are discussed in the following section.
